# Manhole Inspection Summary

Manhole # S39A\_\_042MH

Insp Date: **11/29/07 9:35 AM**

**Location** Address: **mcelderry st**

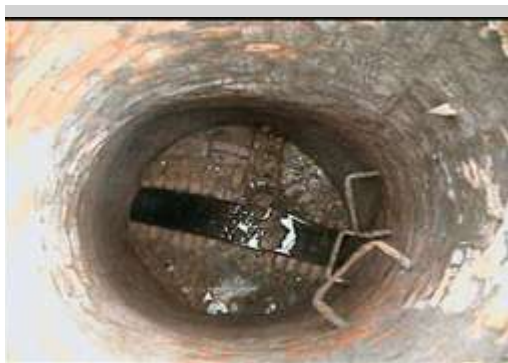
Defect 1

Condition: ☐ Sound ☐ Cracked ☐ Root Intrusion ☒ **Loose Brick** ☐ Deteriorated

Count: **5** Missing: **1** ☒ **Corroded**

missing/corroded steps, channel debris, corbel has loose brick with infiltration from mortar

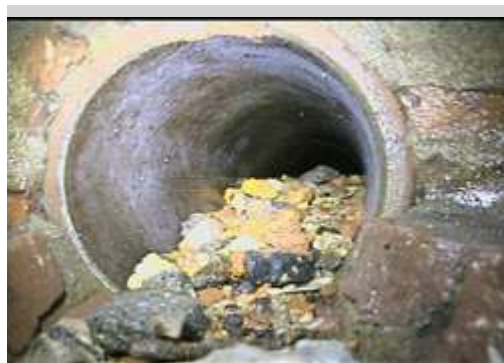
Defect 2

Condition: ☐ Sound ☐ Cracked ☐ Root Intrusion ☐ Deteriorated ☐ Leaks ☒ **Debris**

channel debris

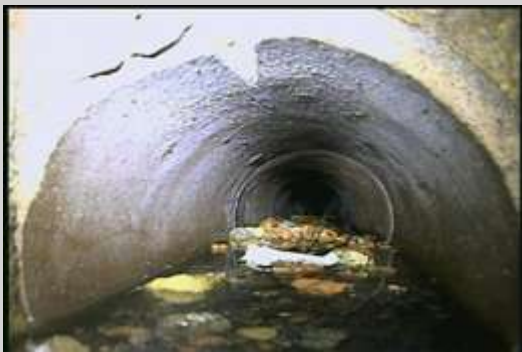
12 O'Clock Outflow

8 in. Circular Gravity Sewer  
Pipe Out @ 12 O'Clock

Deposits: ☐ None ☐ Mud ☐ Sludge ☒ **Debris** ☐ Grease

Silt Depth: 2 (in.) Deposits Extent: **Light**

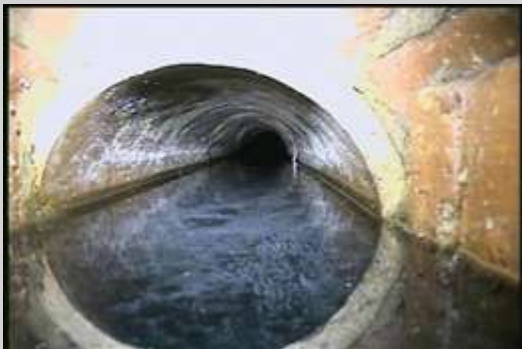
6 O'Clock Inflow

8 in. Circular Gravity Sewer  
Pipe In @ 6 O'Clock

Deposits: ☐ None ☐ Mud ☐ Sludge ☒ **Debris** ☐ Grease

Silt Depth: 2 (in.) Deposits Extent: **Light**

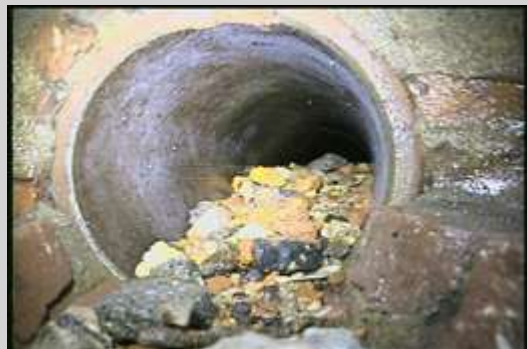
9 O'Clock Inflow

8 in. Circular Gravity Sewer  
Pipe In @ 9 O'Clock

Deposits: ☐ None ☐ Mud ☐ Sludge ☒ **Debris** ☐ Grease

Silt Depth: **3** (in.) Deposits Extent: **Medium**
